## Dual-View Imaging Report

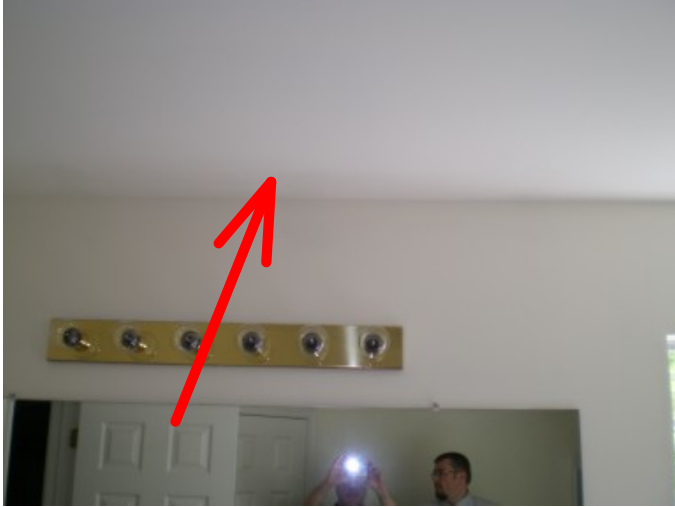
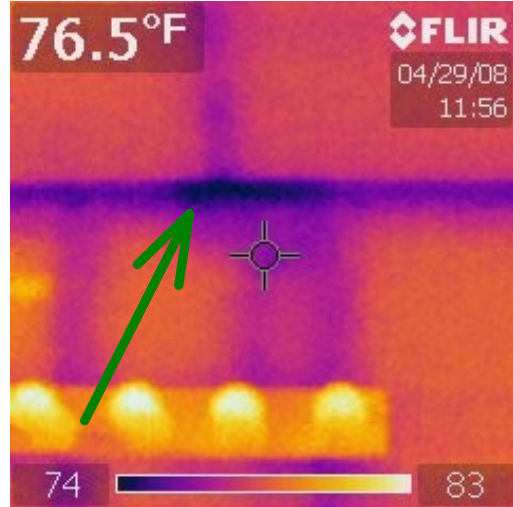
Observations:  
Moisture in sheetrock at risk

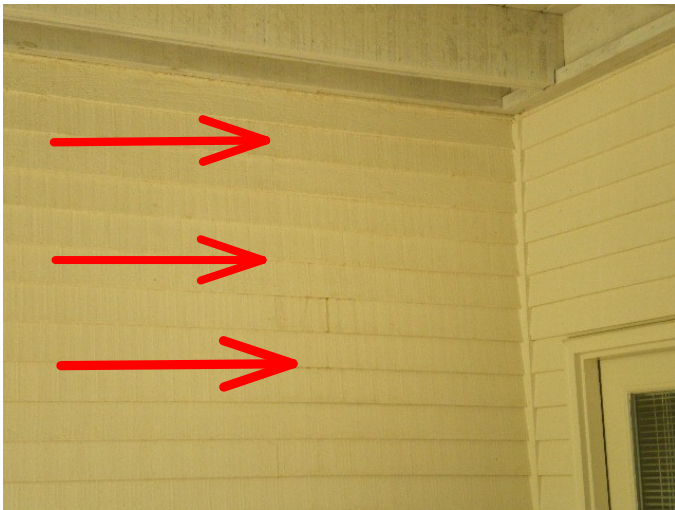
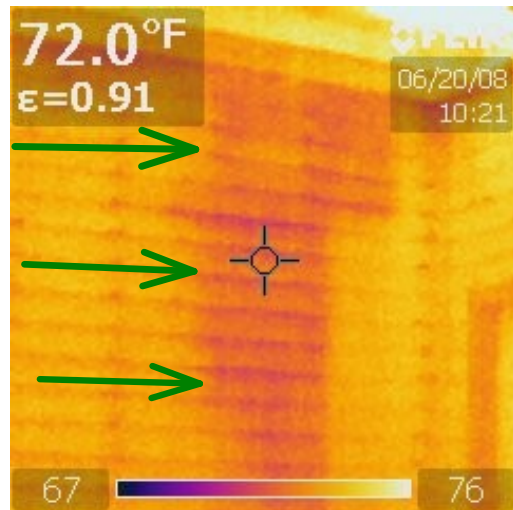
Location Floor: Basement  
Location Room: Bedroom

Observations:  
New Item 1, Moisture detected behind Siding.

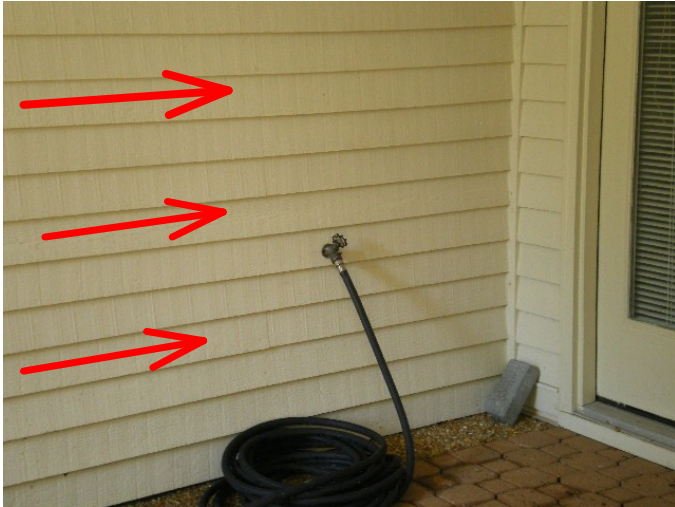
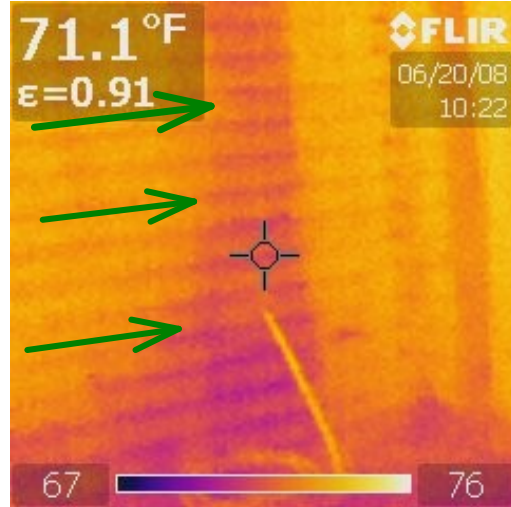
Location Floor: Basement  
 Location Room: Bedroom

Observations:  
 Moisture detected behind Siding.

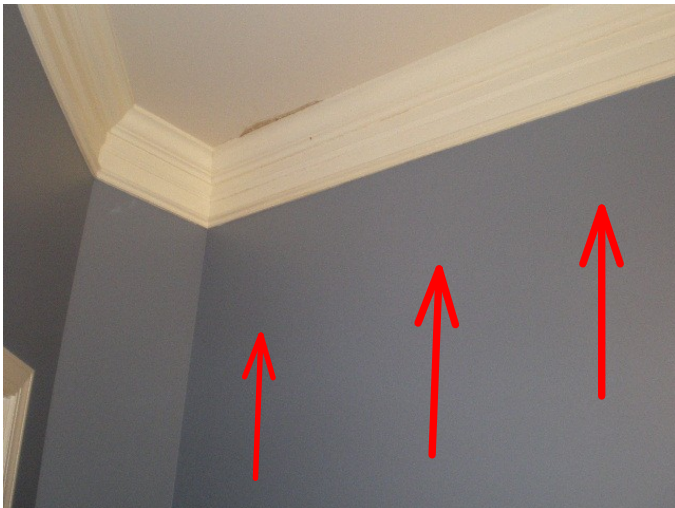
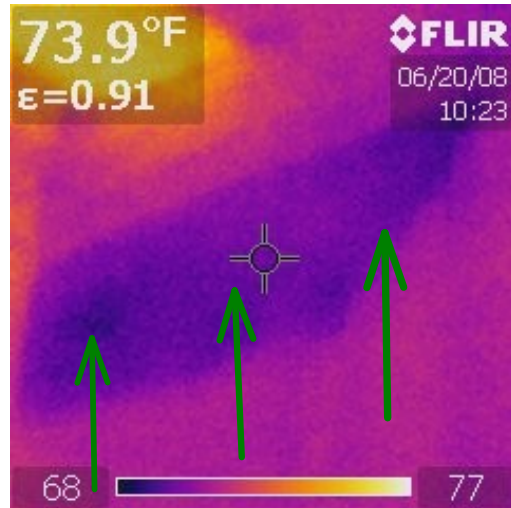
Location Floor: Basement  
 Location Room: Bedroom

Observations:  
 Moisture detected in sheetrock.

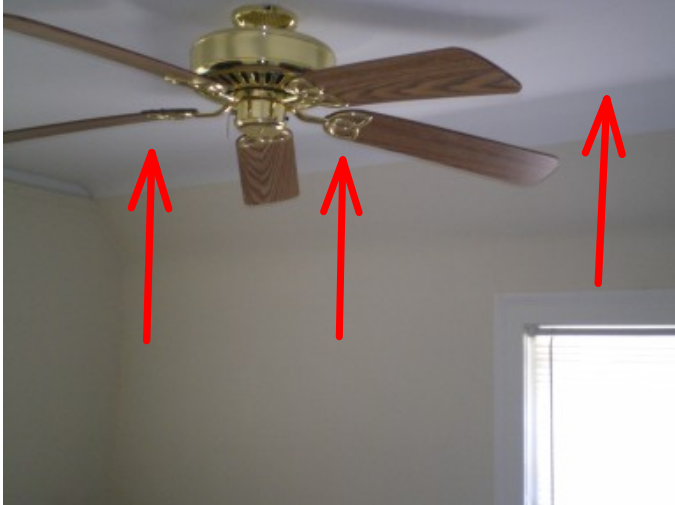
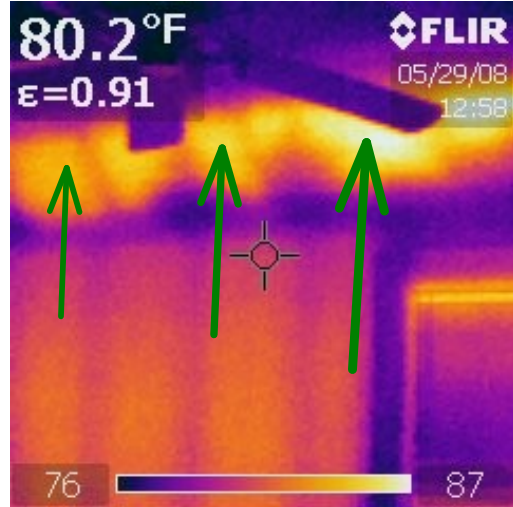
Location Floor: 2nd Floor  
Location Room: Bedroom

Observations:  
Missing Insulation

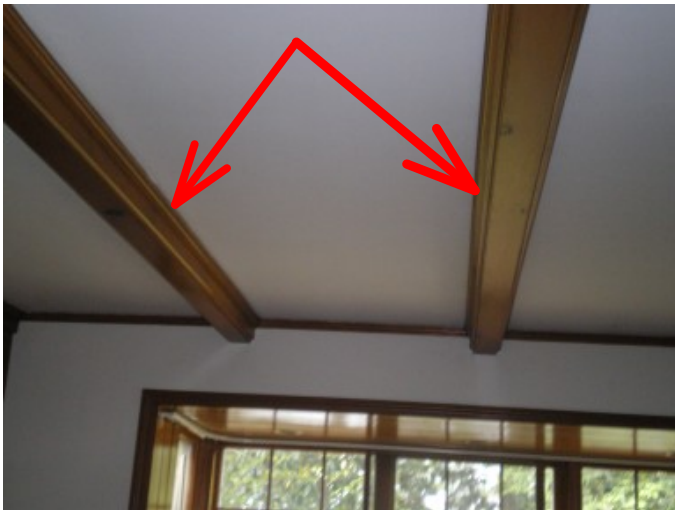
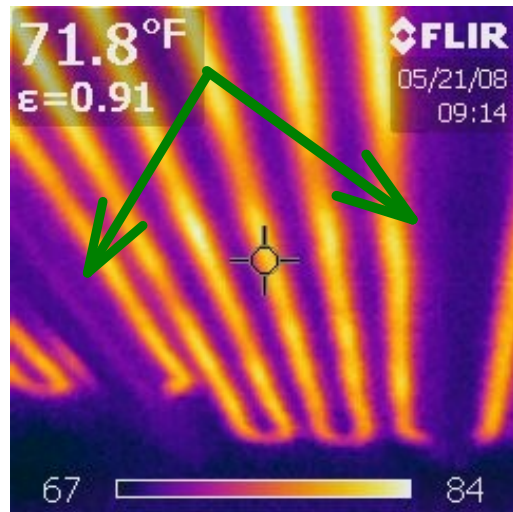
Location Floor: 1st Floor  
Location Room: Family Room

Observations:  
Radiant ceiling with exposed wood beams.
